CONFERENCE ON AEROSPACE TRANSPARENT MATERIALS AND ENCLOSURES

18-21 NOVEMBER 1975
ATLANTA, GEORGIA

TECHNICAL REPORT AFML-TR-76-54

AIR FORCE MATERIALS LABORATORY
AIR FORCE WRIGHT AERONAUTICAL LABORATORIES
AIR FORCE SYSTEMS COMMAND
WRIGHT-PATTERSON AIR FORCE BASE, OHIO 45433

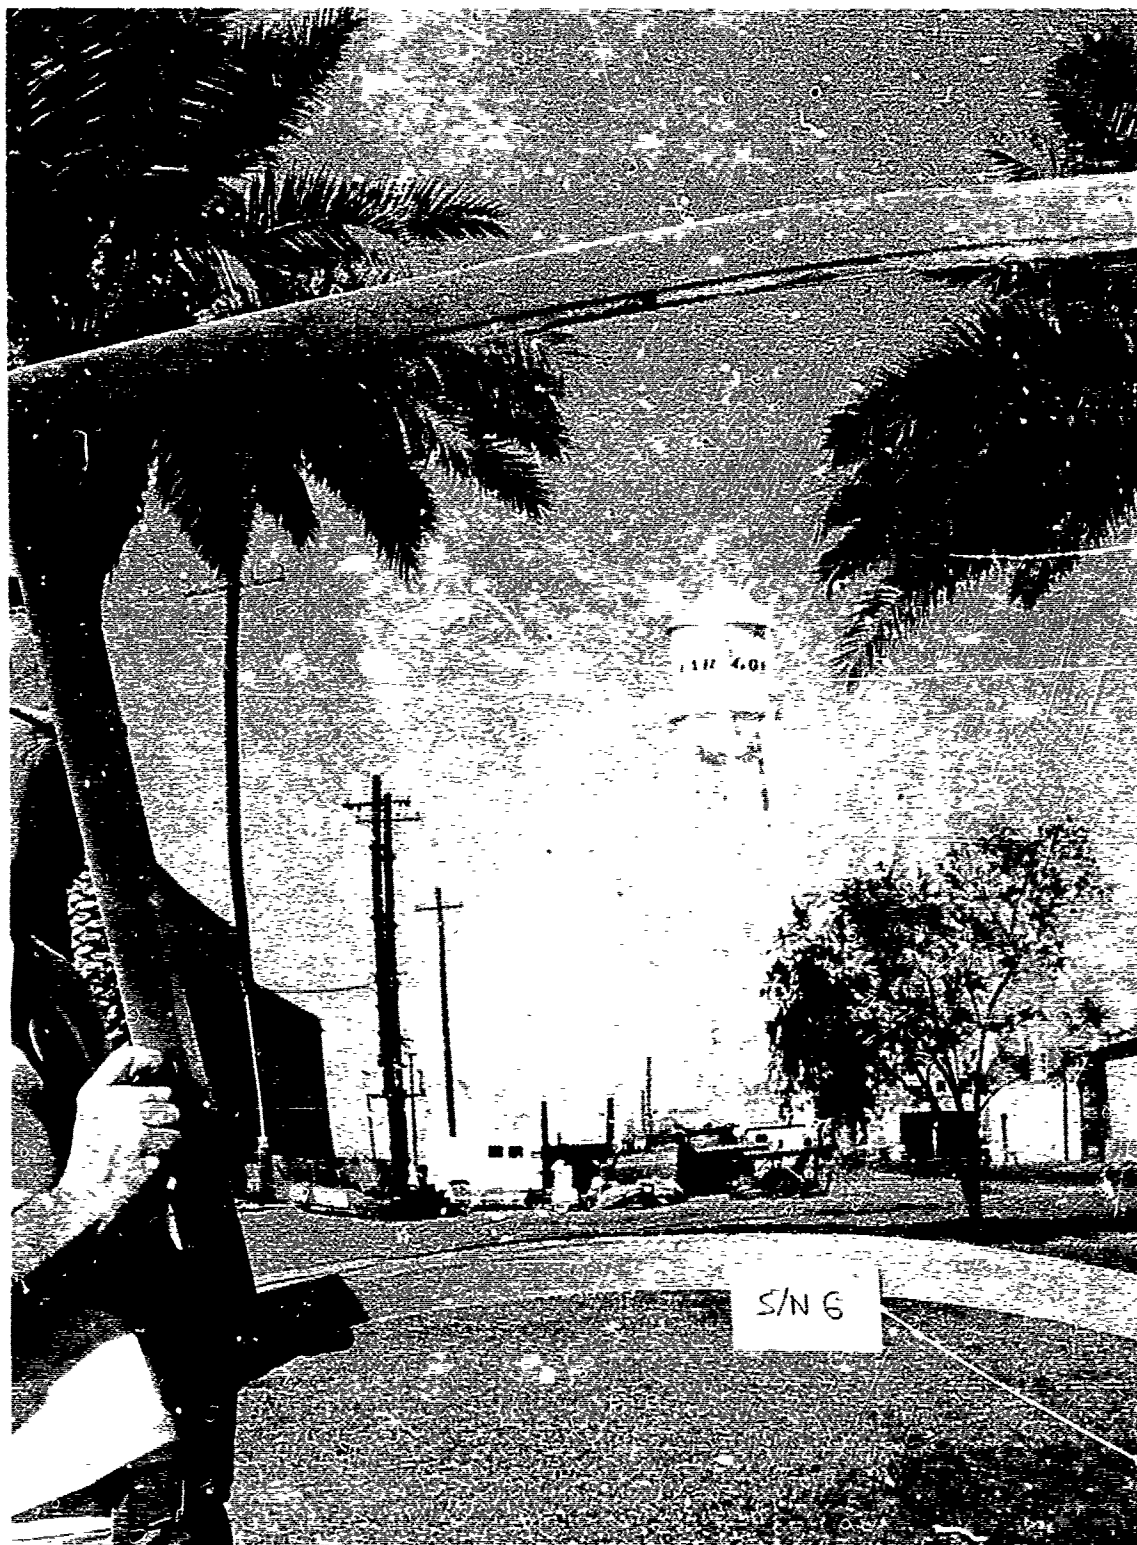
Figure 7 - Glass/Polycarbonate Prototype

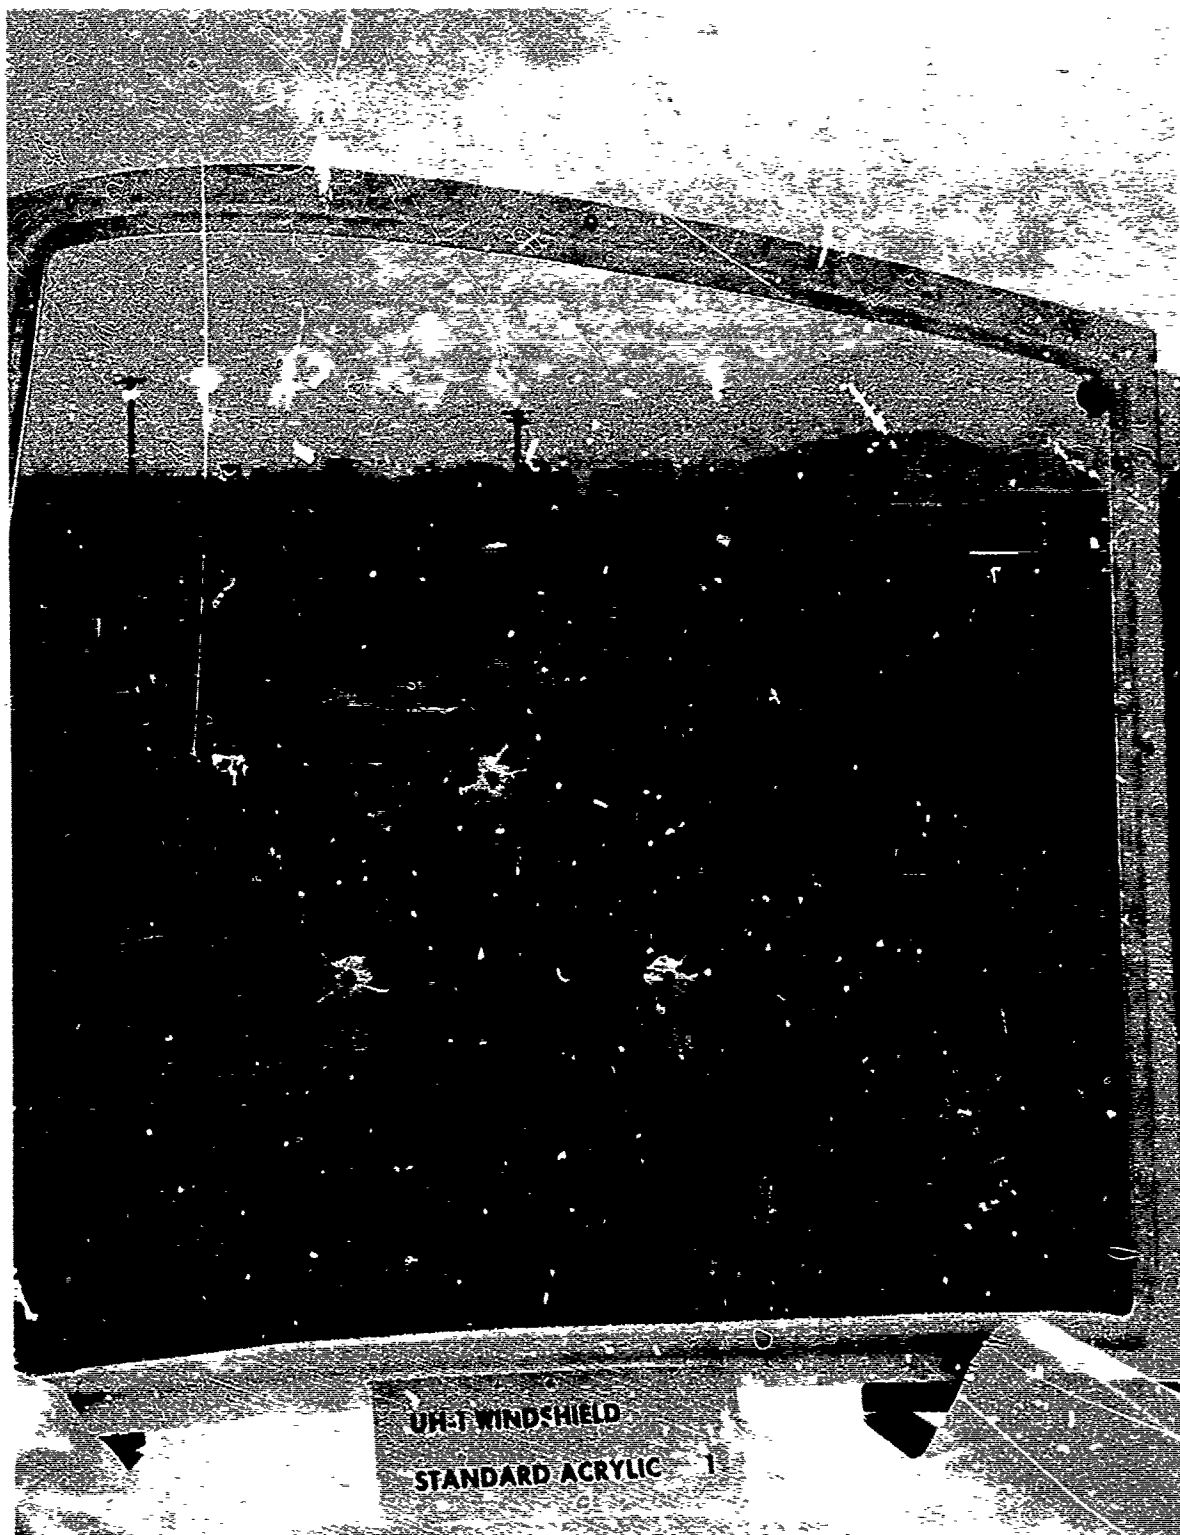
Figure 11 - UH-1 Standard Acrylic Windshield, Ballistic Test Article, Post-Test Display

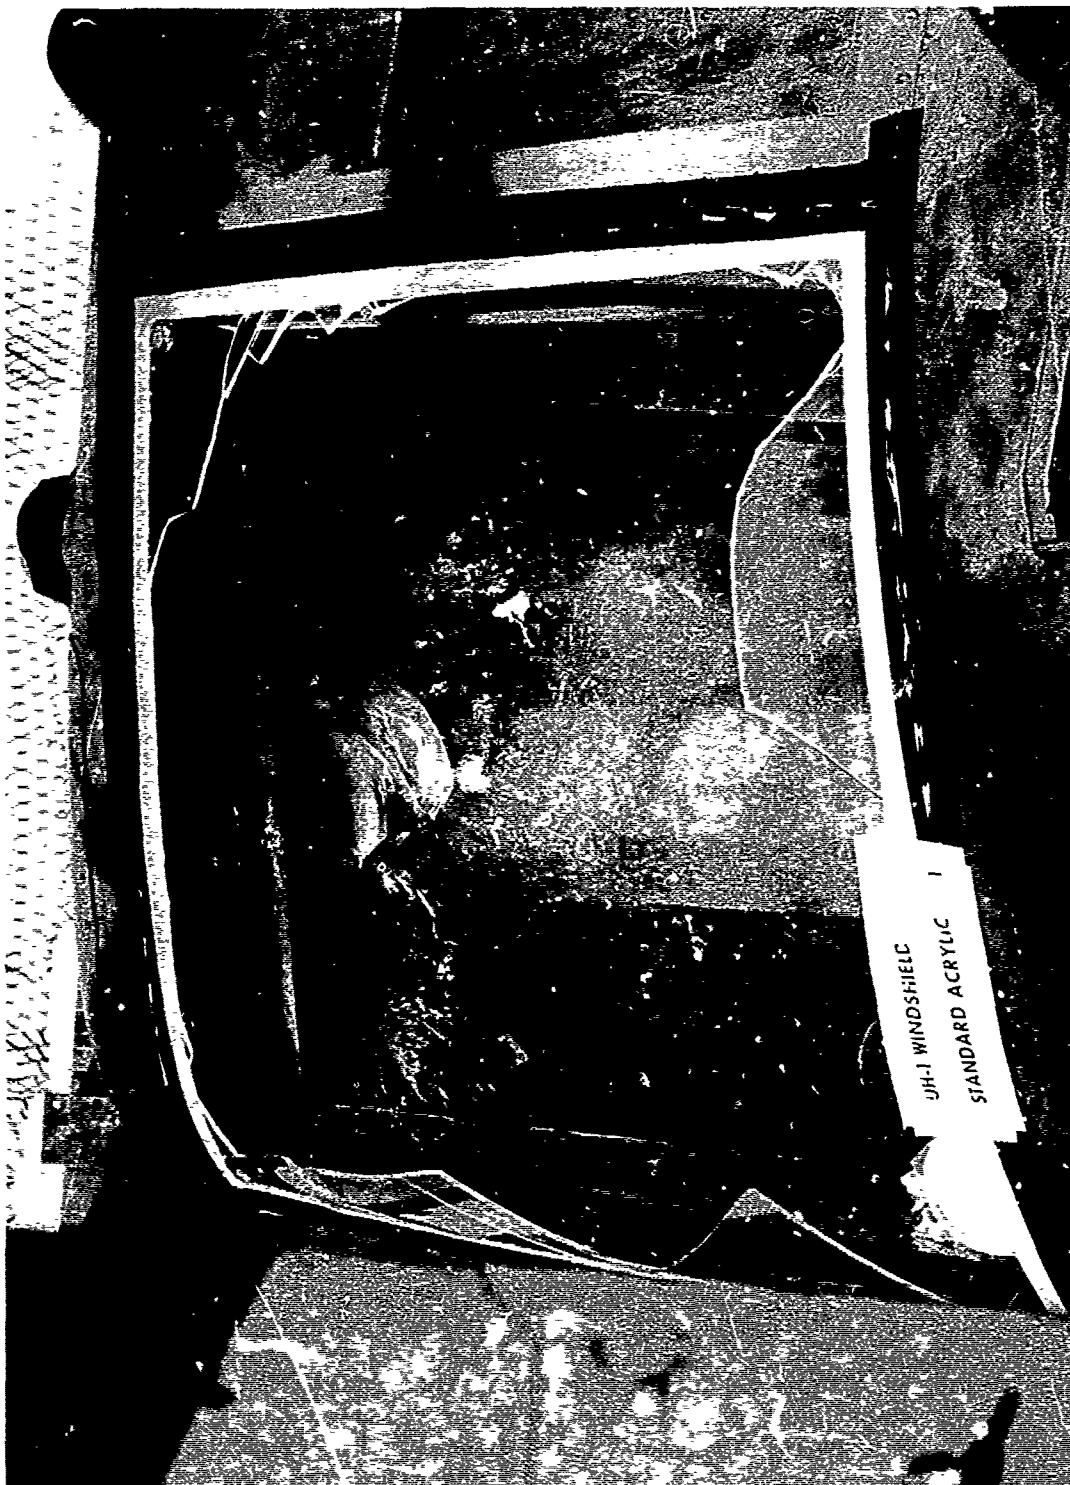
Figure 28 - Bird-Impacted UH-1 Standard Acrylic Windshield Number 1

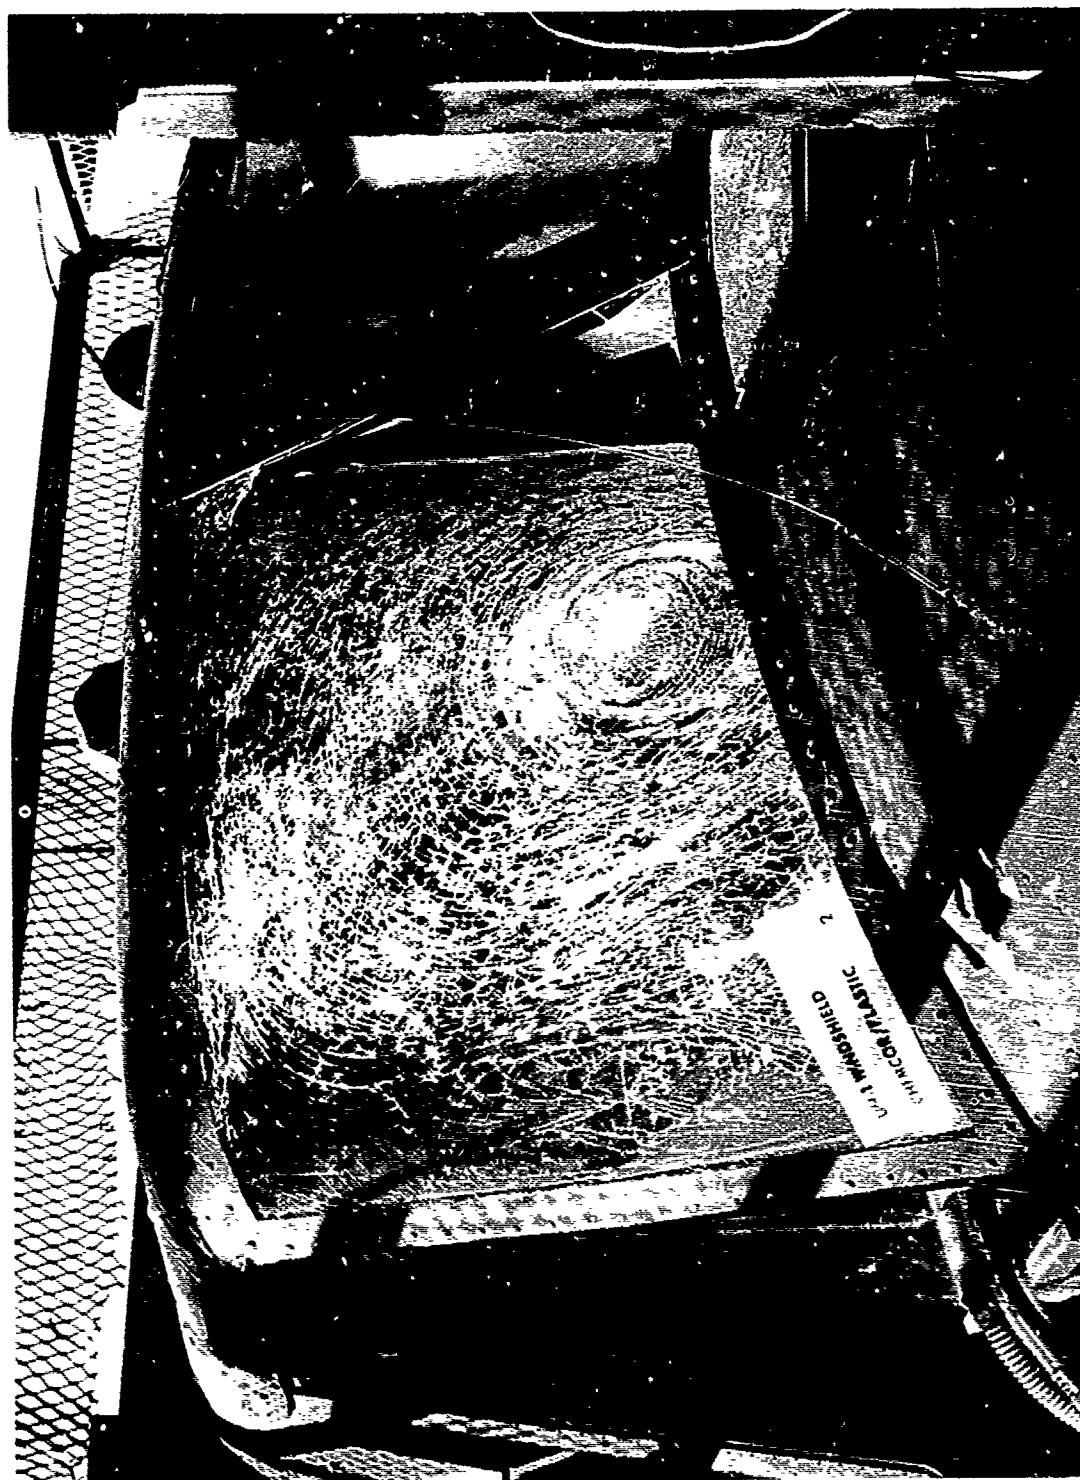
Figure 31 - Bird-Impacted UH-1 Chemcor-Plastic Windshield Number 2
